Attachment A: Digital Images

May 21st, 2008 Assessment

BOE 22nd Floor Break Room 2202, 2223, and 2224 Clearance
Sacramento, CA

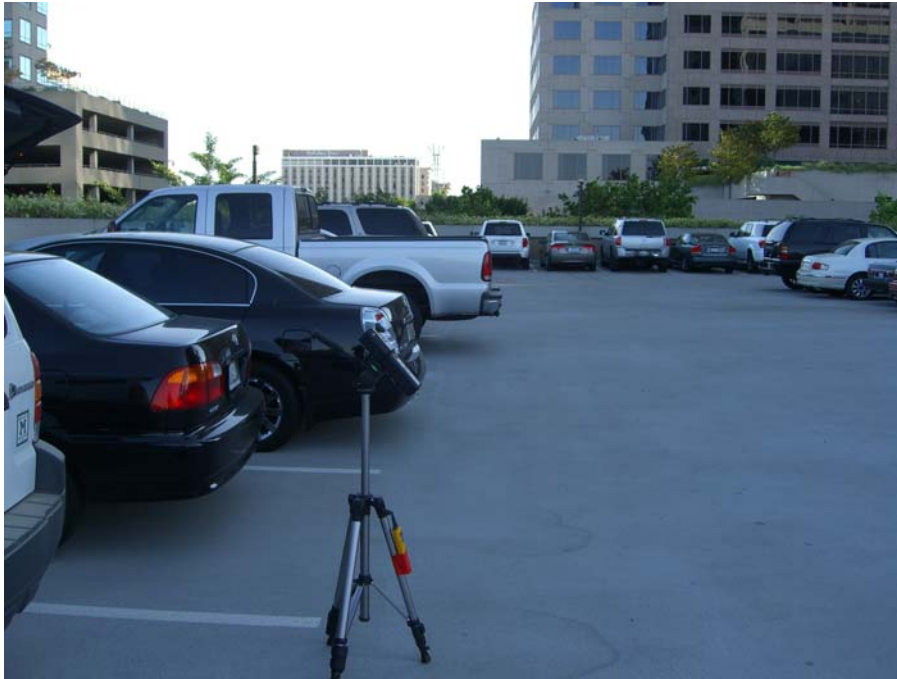
- 1) Image of ambient air sampling location at rooftop of garage structure adjacent to the BOE building (Subject Building) located at 450 N Street, Sacramento.

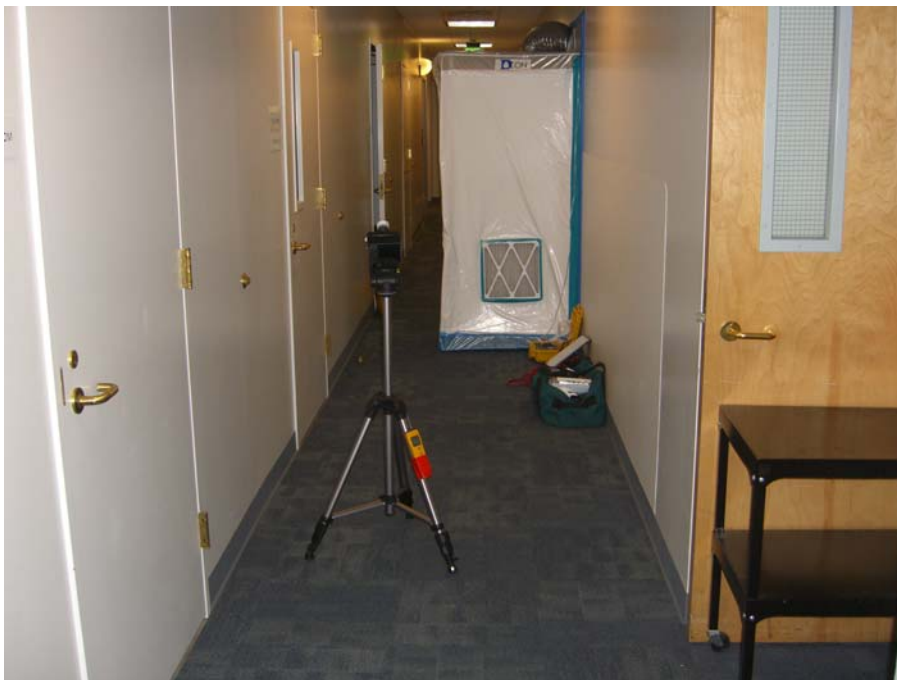
- 2) Image of air sampling equipment located within hallway of 22nd Floor near 2202 break room containment.

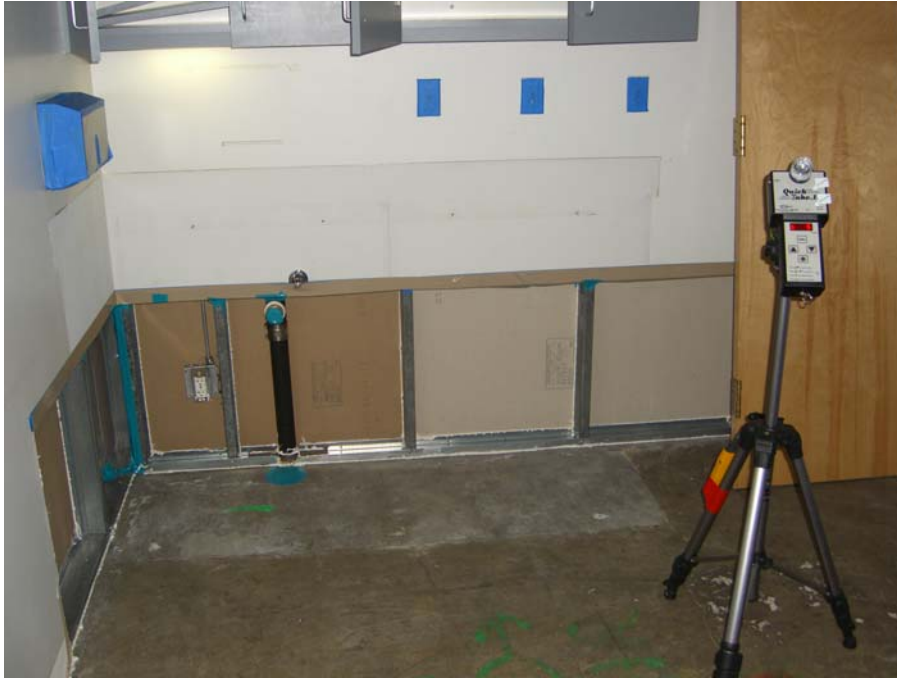
- 3) Image of wall removal delineation and air sampling activity performed within Break Room 2202 at time of assessment.

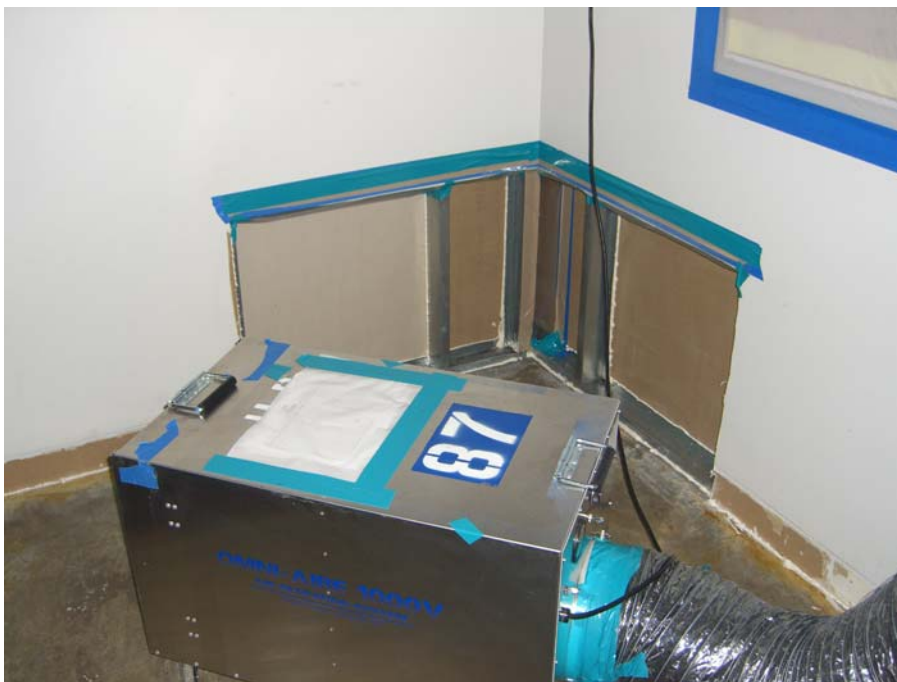
- 4) Image of adjacent wallboard removal delineation performed within Break Room 2202 as part of mitigative activity.

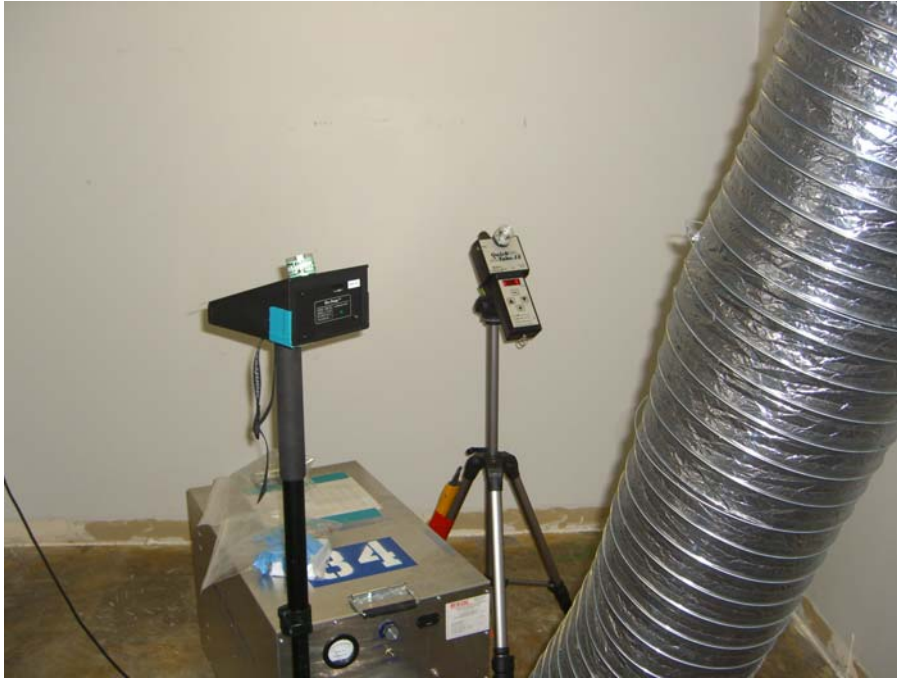
- 5) Image of BioMax and HTI air sampling equipment oriented within Break room 2223 at time of assessment.

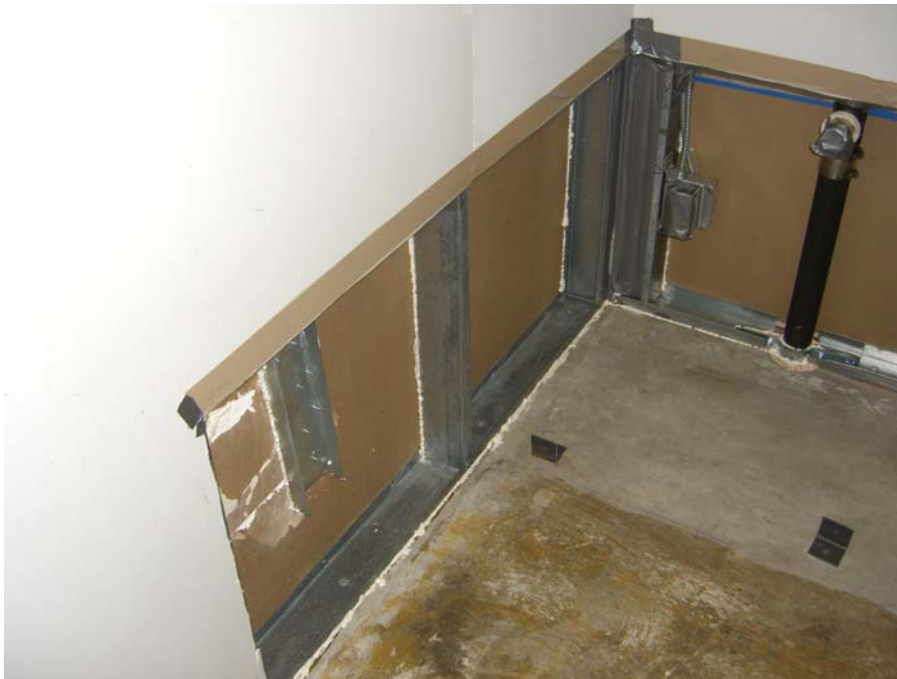
- 6) Image of wallboard removal delineation performed within 2223 at time of assessment.

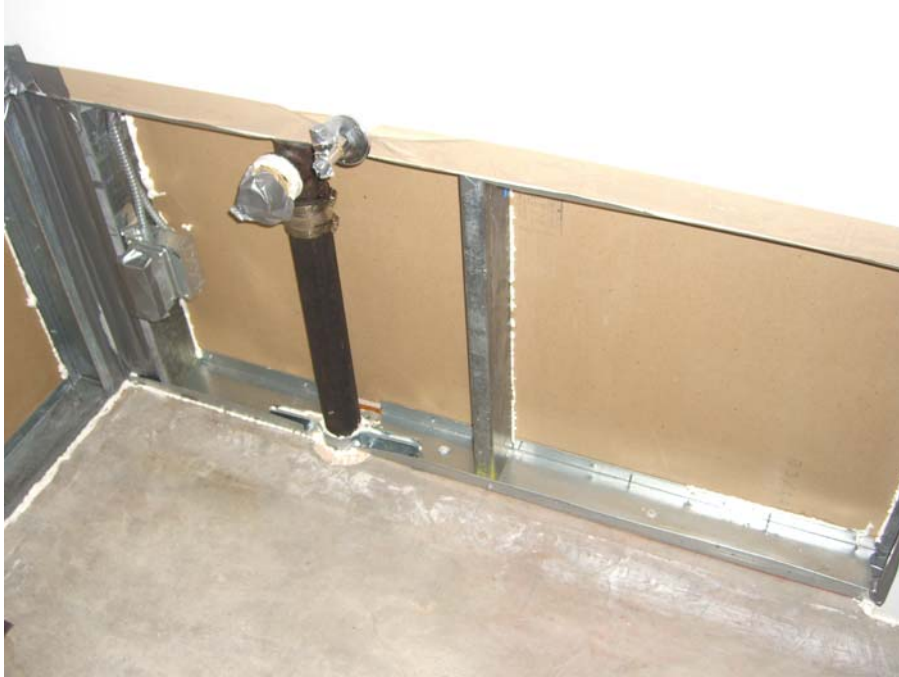
- 7) Additional perspective image indicating extent of wallboard removal performed within break room 2223 as part of the mitigative activity.

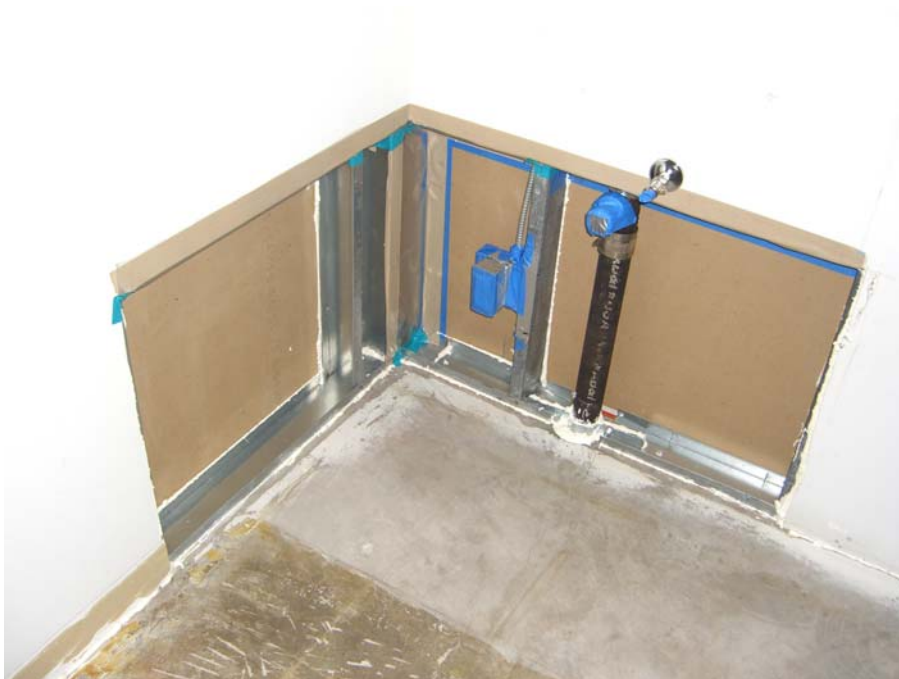
- 8) Image of wallboard removal delineation performed within Employee Lounge (Break Room 2224) as part of the mitigative efforts.

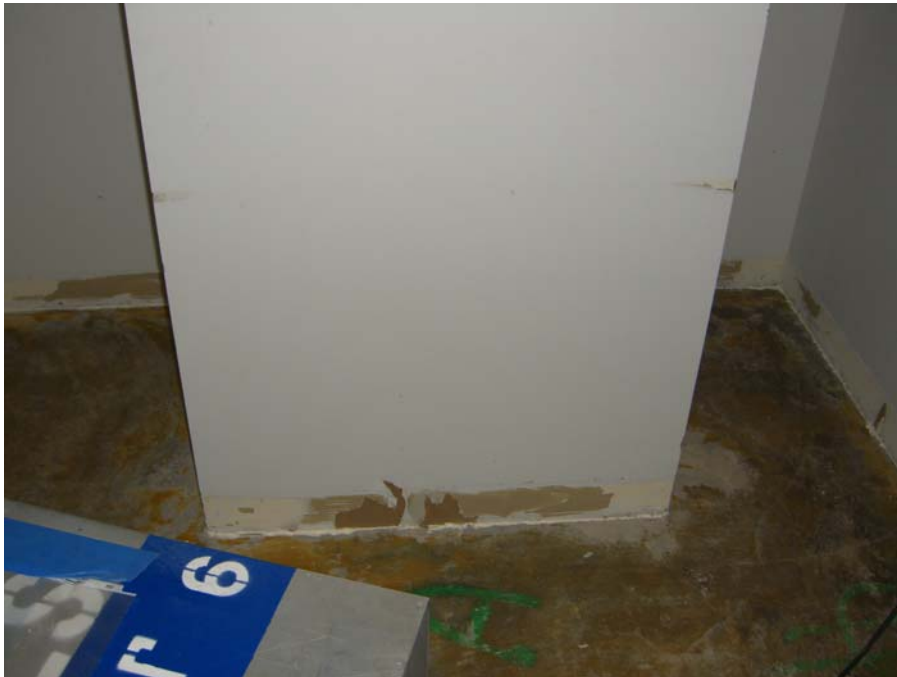
- 9) Image of baseboard removal performed within 2224 at structural support chase area. No visual indications of staining were observed at the time of assessment.

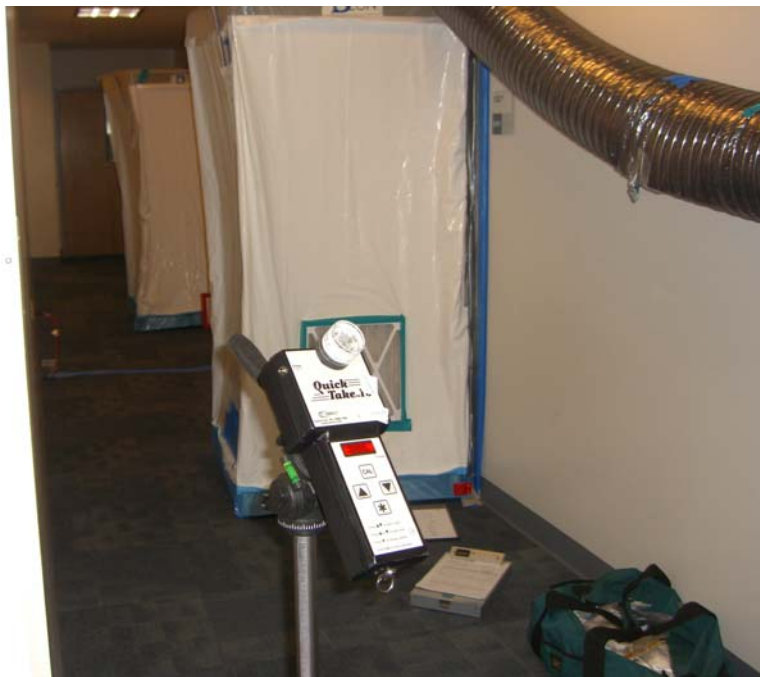
- 10) Image of air sampling activity performed in hallway adjacent to 2223 and 2224 containment areas.

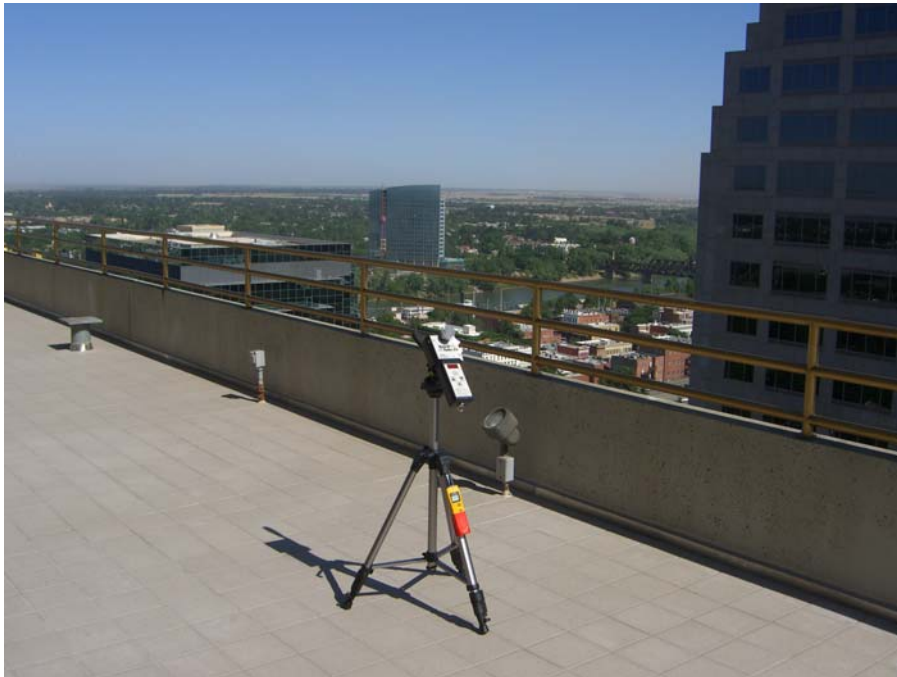
11) Image of ambient air sample location on 23rd floor northern balcony following the sample collection of interior samples.

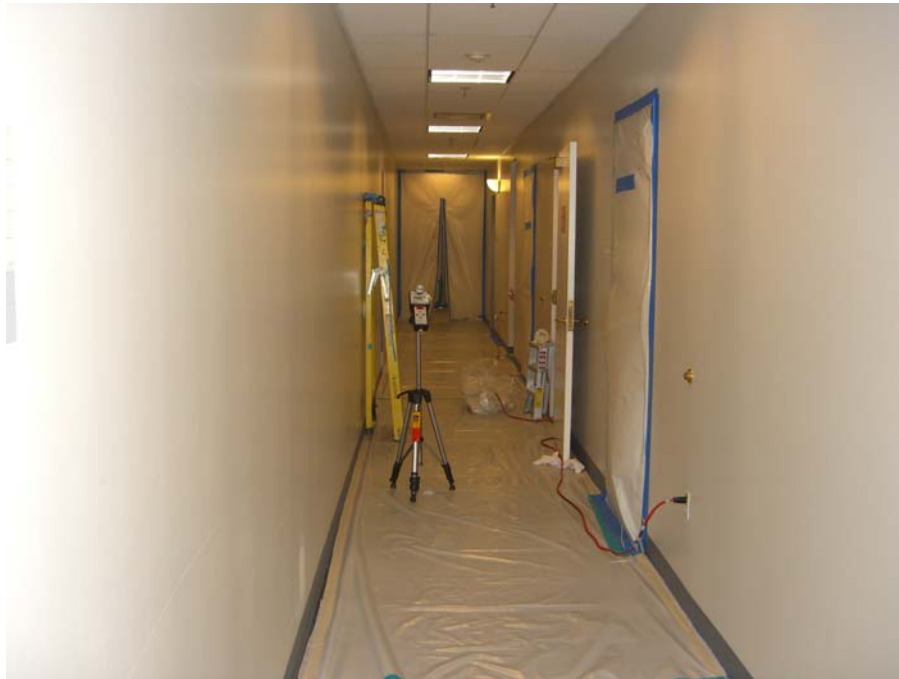
12) Image of air sampling performed within hallway near men's restroom area at time of assessment.

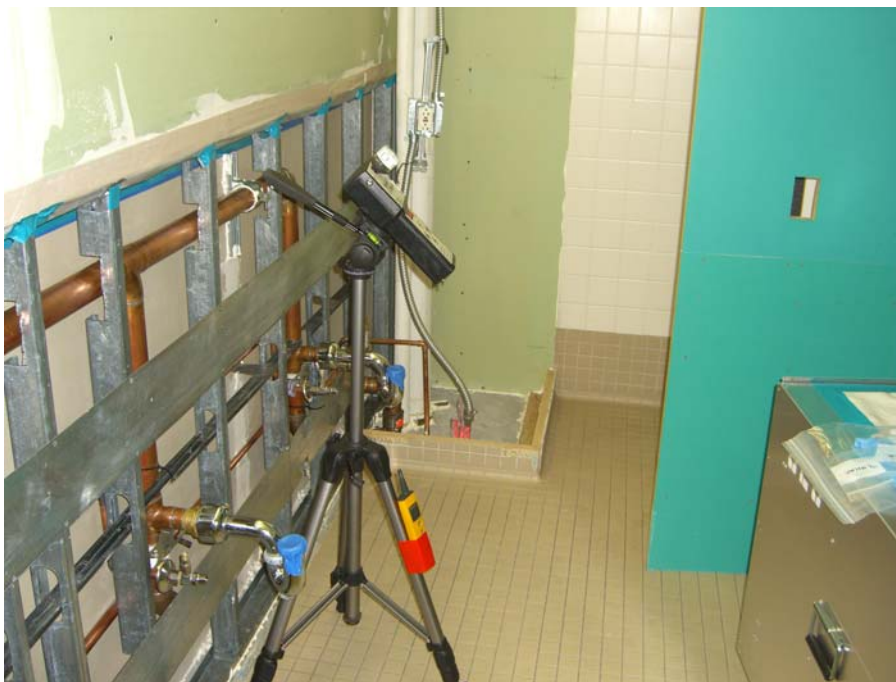
13) Image of wallboard removal and exposed plumbing within men's restroom area following mitigative activity.

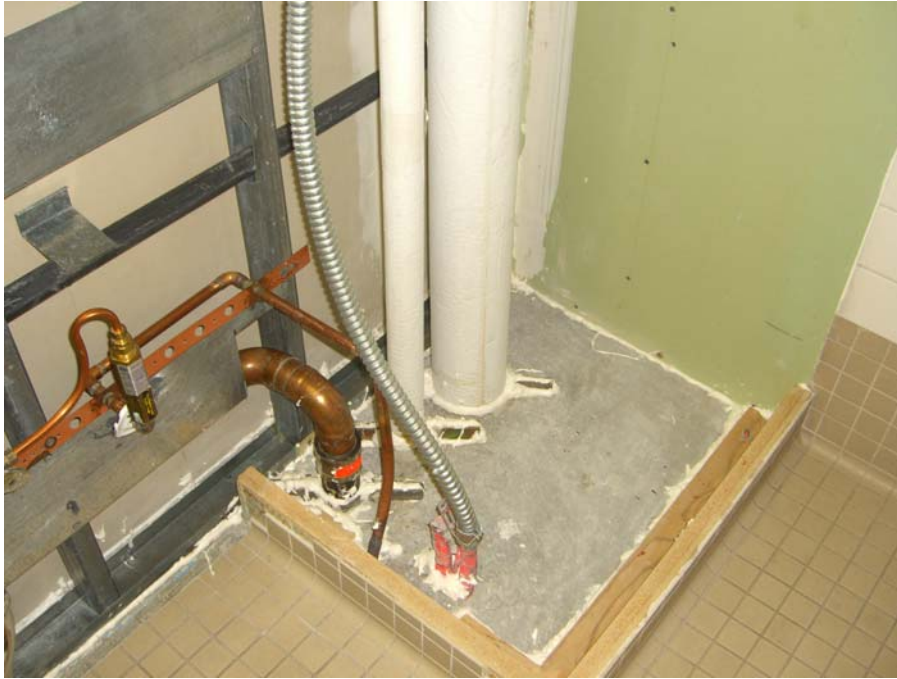
14) Close up image of paper towel chase and interior plumbing systems located to the right of sink area within men's restroom following mitigative activity.

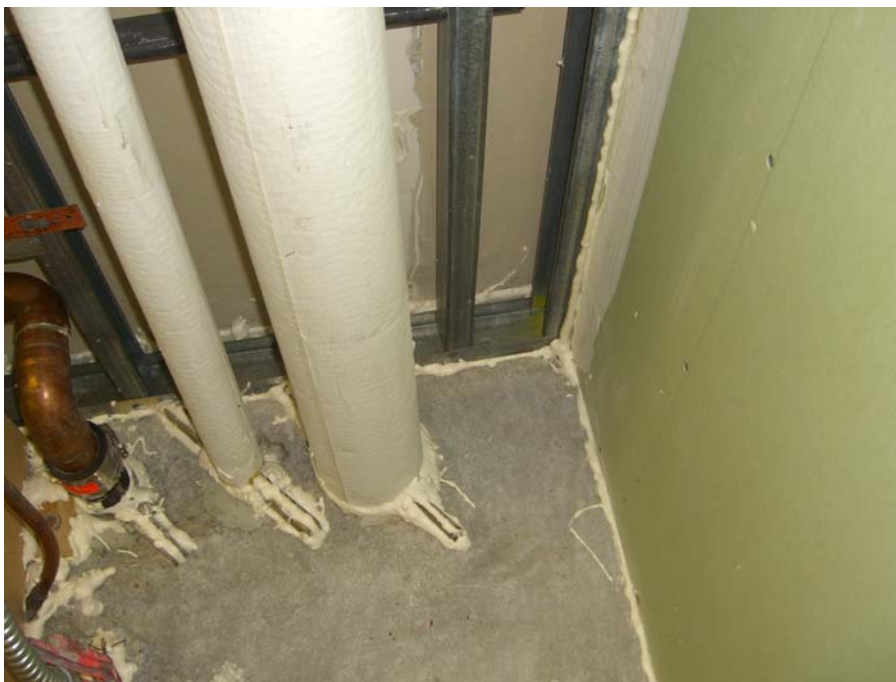
15) Close-up image of wall surface behind right-side paper towel cavity. Noted absence of elevated staining present on wall surface leading to elevator shaft.

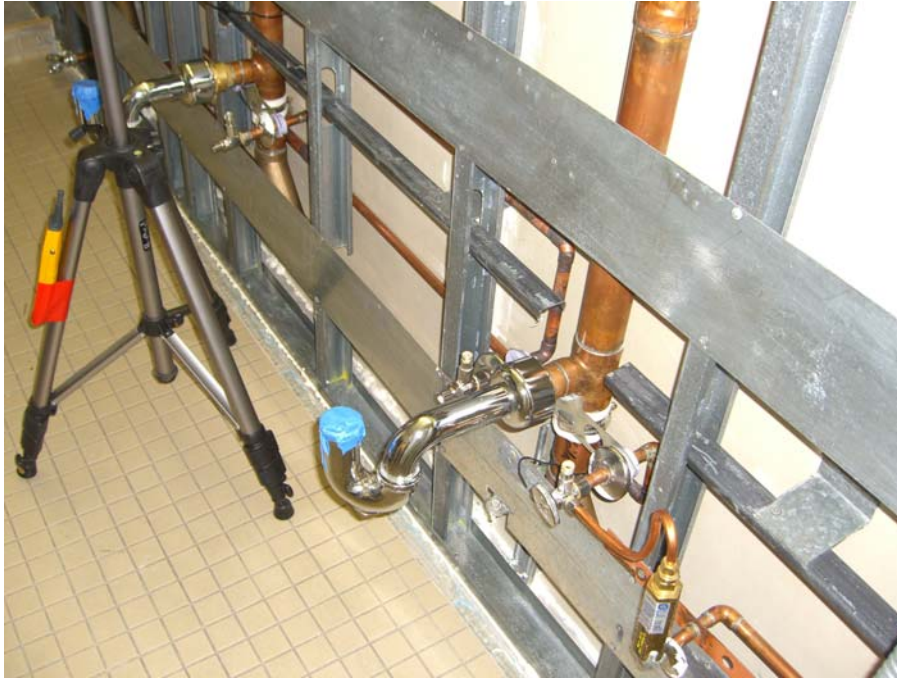
16) Close up image of exposed plumbing and metal framing located at sink area within men's restroom following mitigative removal.

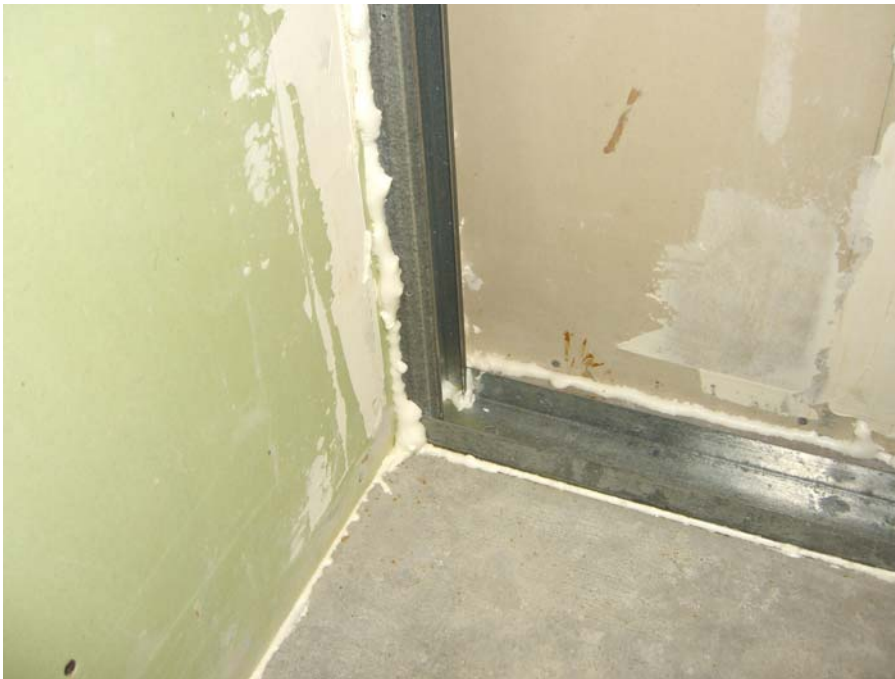
17) Close-up image of wallboard material to left side of prior sink cabinet location. Absence of elevated staining present on wallboard adjacent to elevator shaft system.

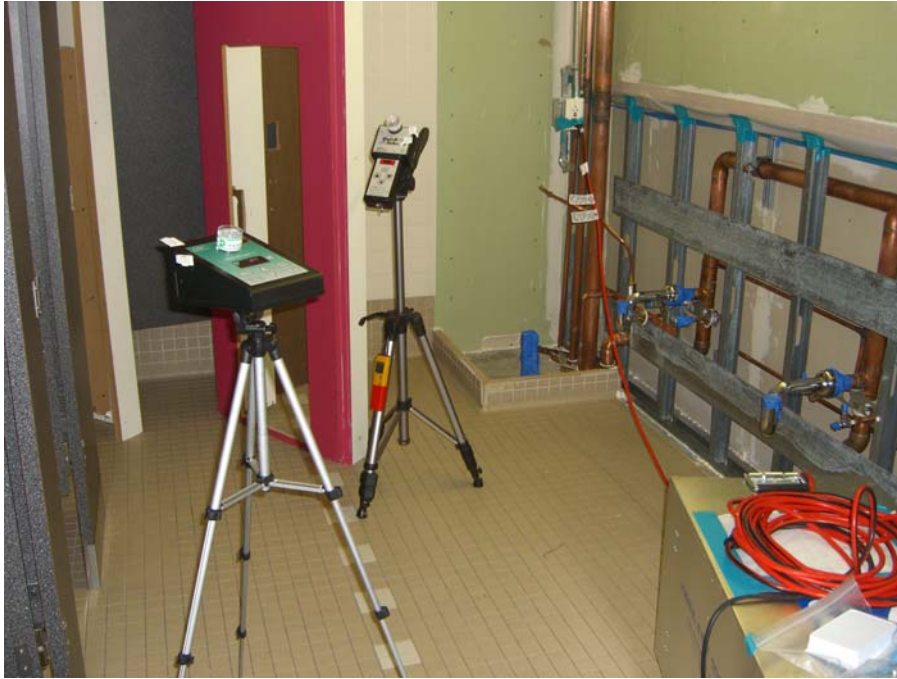
18) Image of BioMax and HTI air sampling activities performed within women's restroom containment area at time of assessment.

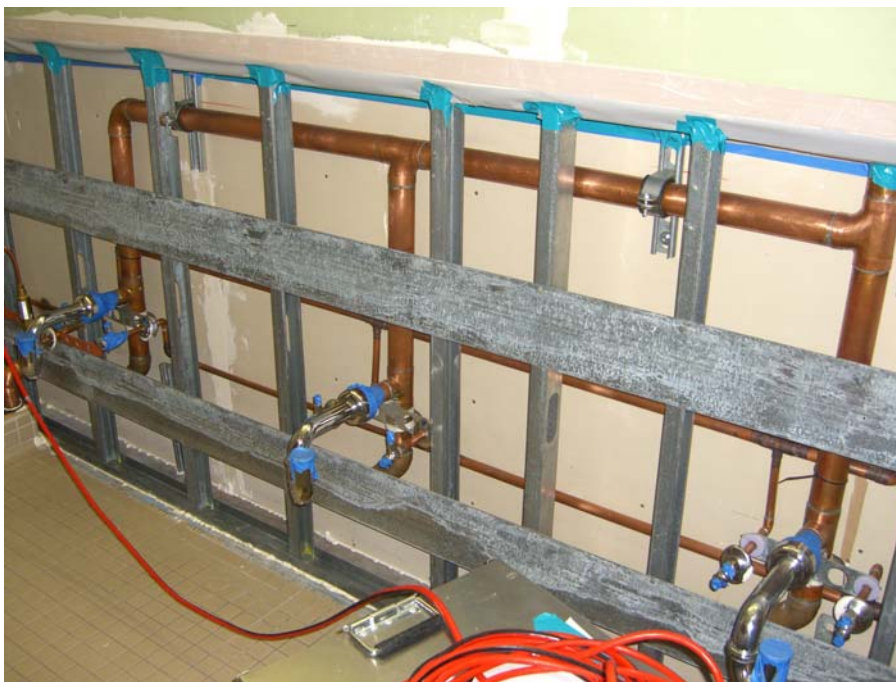
19) Image of plumbing structures and underlayment materials within women's restroom containment area at time of assessment.

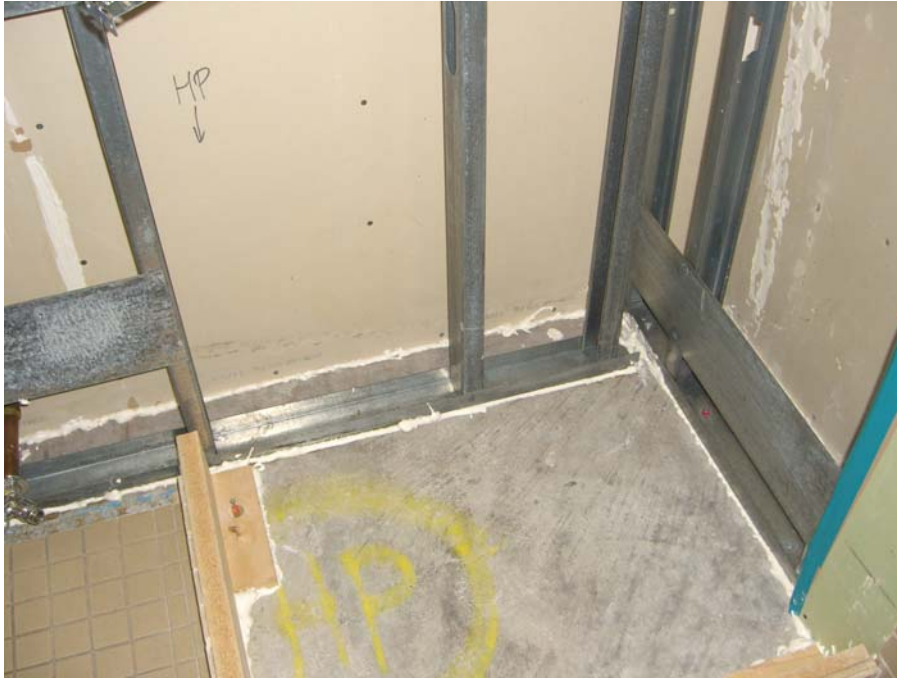
20) Close up image of exposed wallboard material to right of prior sink cabinet location of women's restroom. Absence of elevated staining noted on wall surface.

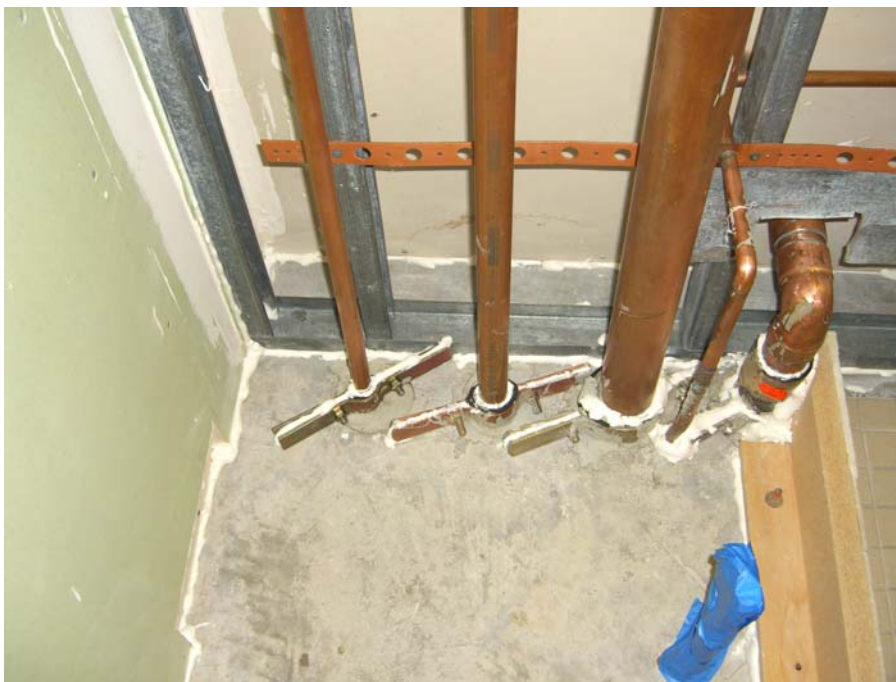
21) Image of "paper towel" cavity to left of prior sink within women's restroom area. Absence of elevated staining noted on underlayment wall surface adjacent to elevator shaft.
